**Flood Control Project Maintenance**  
**Levee Inspections**

**Fall 2011 Levee Maintenance Deficiency Summary Report**

**Sacramento River Basin**

**Sacramento Maintenance Yard Maintenance Area 0009**

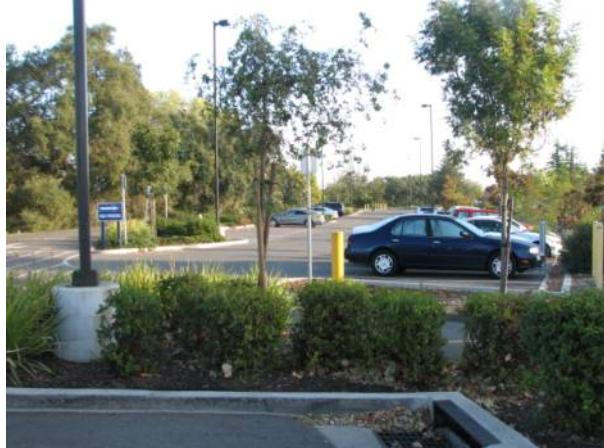
Levee Mile Report Line	2
Start Levee Mile	0.40
End Levee Mile	0.48
Location	Crown
Category	Earthen Levee
Item	Encroachments
A view of the parking area and landscape. Fall 2011

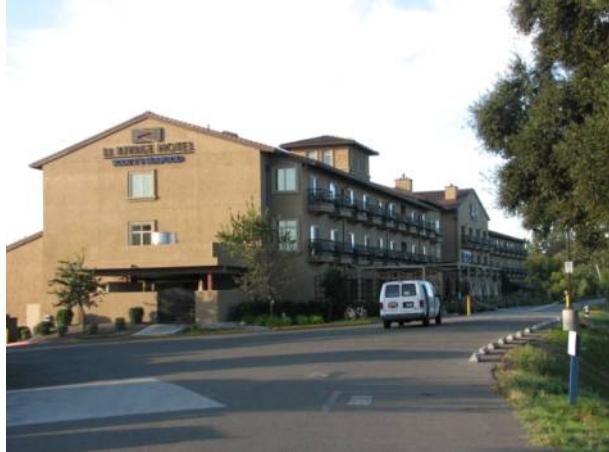
Levee Mile Report Line	4
Start Levee Mile	0.53
End Levee Mile	0.65
Location	Land Side
Category	Earthen Levee
Item	Encroachments
Hotel and restaurant at old Captain's Table, Le Rivage Hotel. Fall 2011

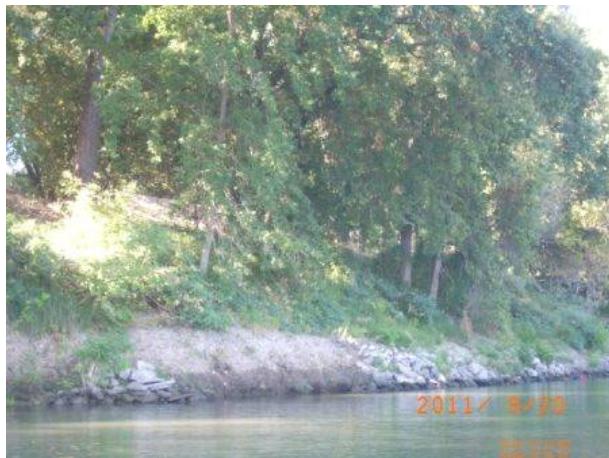
USACE 2011 Photo #1

Levee Mile Report Line	5
Start Levee Mile	0.64
End Levee Mile	0.88
Location	Water Side
Category	Supplemental
Item	USACE Erosion Survey

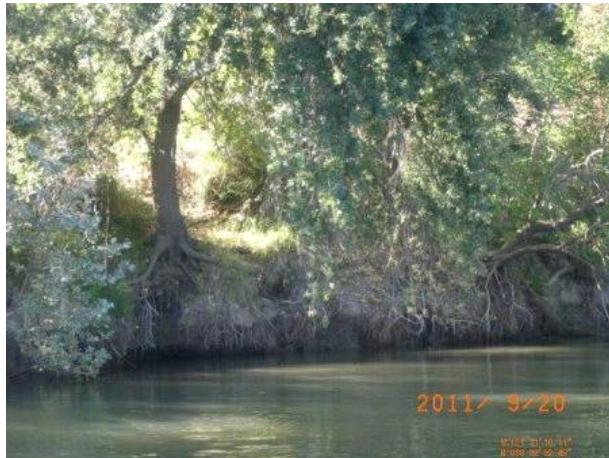
USACE 2011 Photo #2

Levee Mile Report Line	5
Start Levee Mile	0.64
End Levee Mile	0.88
Location	Water Side
Category	Supplemental
Item	USACE Erosion Survey

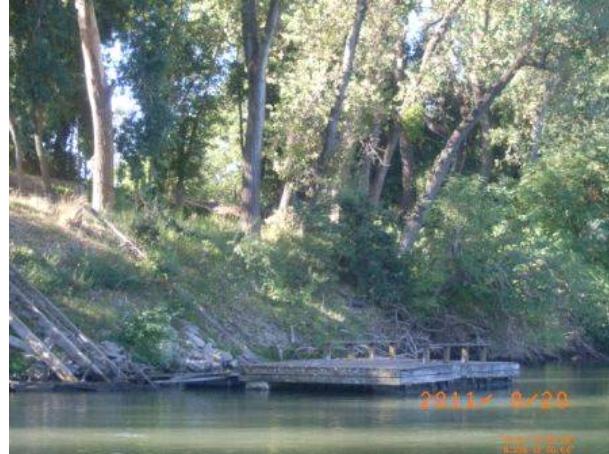
USACE 2011 Photo #3

Levee Mile Report Line	5
Start Levee Mile	0.64
End Levee Mile	0.88
Location	Water Side
Category	Supplemental
Item	USACE Erosion Survey

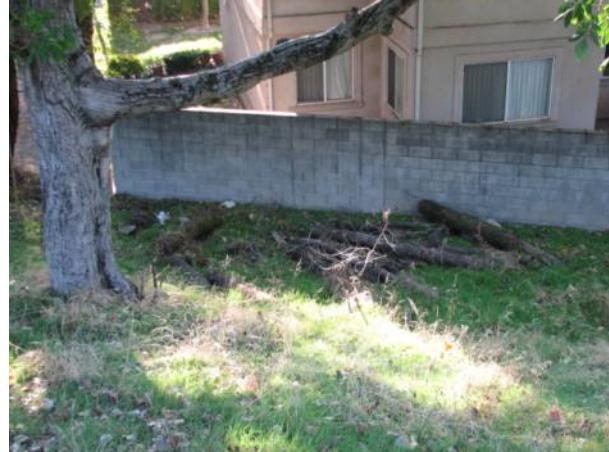
Levee Mile Report Line	8
Start Levee Mile	0.72
End Levee Mile	0.72
Location	Land Side
Category	Earthen Levee
Item	Encroachments
Tree limbs and brush at the toe left from trimming trees. Fall 2011	
johngw_f_20111107_504.jpg

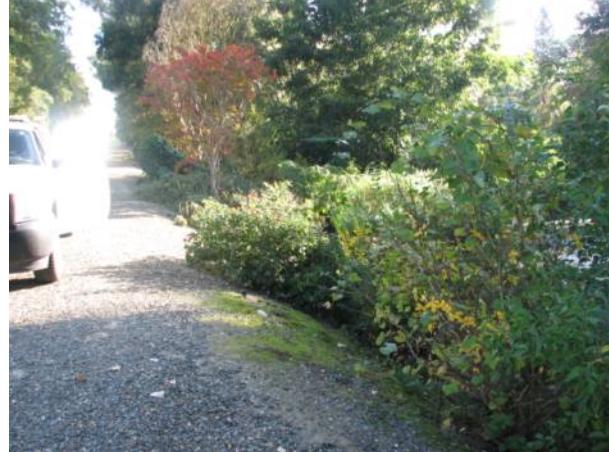
Levee Mile Report Line	16
Start Levee Mile	0.93
End Levee Mile	0.94
Location	Land Side
Category	Earthen Levee
Item	Encroachments
Landscape shrubs and trees are blocking visibility of the levee slope. Fall 2011	
<a href="#">johngw_f_20111107_506.jpg</a>

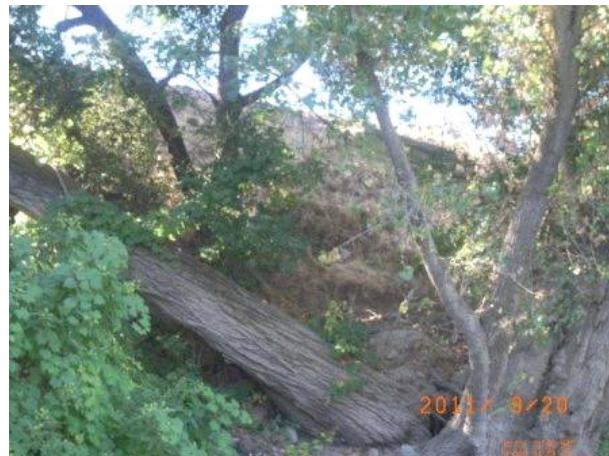
Levee Mile Report Line	25
Start Levee Mile	1.06
End Levee Mile	1.06
Location	Water Side
Category	Supplemental
Item	USACE Erosion Survey
USACE 2011 Photo #1	
<i>USACE2011_SAC_54-8_L_1.jpg</i>

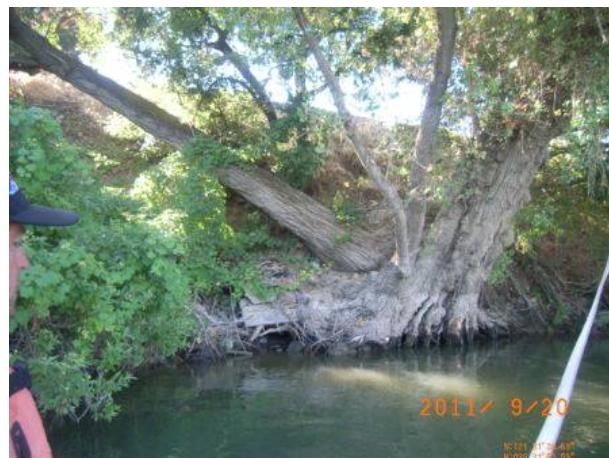
Levee Mile Report Line	25
Start Levee Mile	1.06
End Levee Mile	1.06
Location	Water Side
Category	Supplemental
Item	USACE Erosion Survey
USACE 2011 Photo #2	
<i>USACE2011_SAC_54-8_L_2.jpg</i>

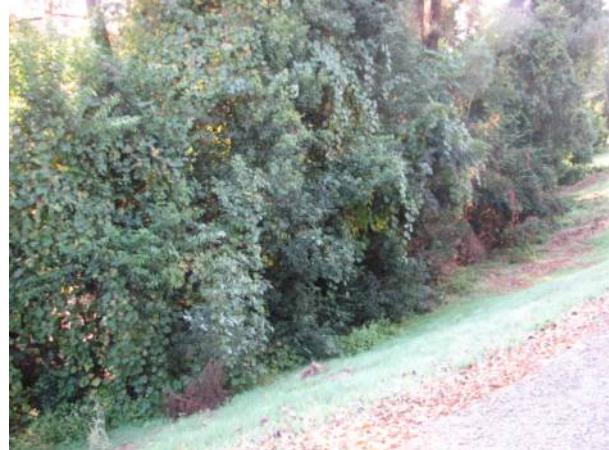
Levee Mile Report Line	27
Start Levee Mile	1.27
End Levee Mile	1.31
Location	Land Side
Category	Earthen Levee
Item	Encroachments
The trees and vegetation makes it hard to see through to the toe. Fall 2011	
<a href="#">johngw_f_20111107_508.jpg</a>

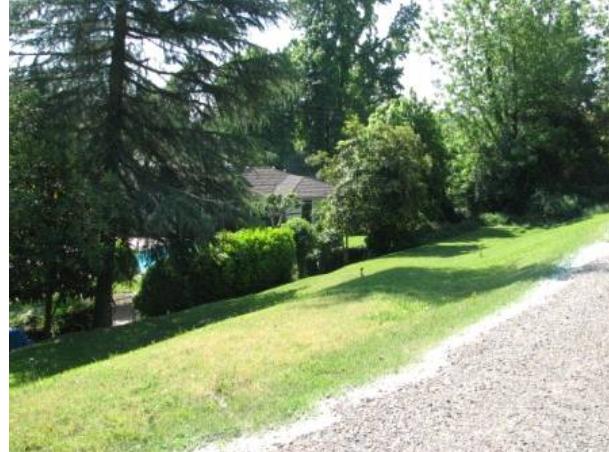
Levee Mile Report Line	29
Start Levee Mile	1.31
End Levee Mile	1.34
Location	Land Side
Category	Earthen Levee
Item	Encroachments
Hedges block the view of the toe and backyard.	
<i>johngw_f_20111007_875.jpg</i>

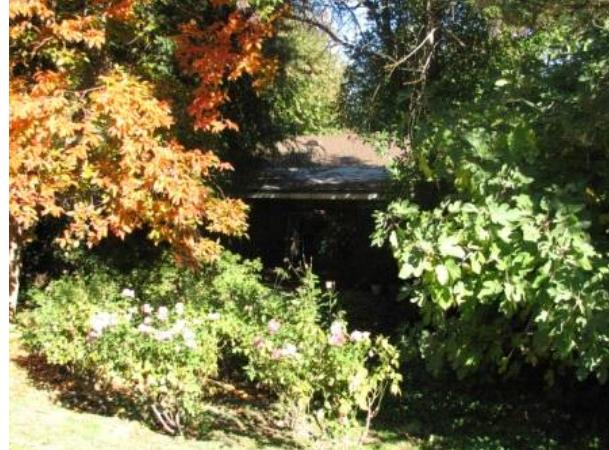
Levee Mile Report Line	37
Start Levee Mile	1.91
End Levee Mile	1.91
Location	Land Side
Category	Earthen Levee
Item	Encroachments
The house is on the crown with landscaping up to the shoulder.	
<a href="#">johngw_f_20111007_881.jpg</a>

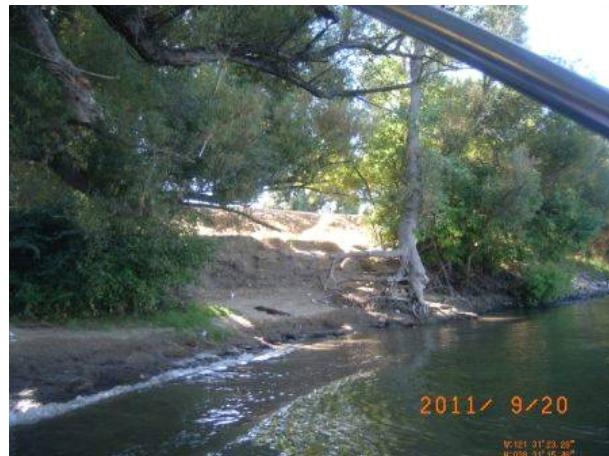
Levee Mile Report Line	38
Start Levee Mile	1.91
End Levee Mile	1.95
Location	Water Side
Category	Supplemental
Item	USACE Erosion Survey
USACE 2011 Photo #1	
<a href="#">USACE2011_SAC_53-8_L_1.jpg</a>

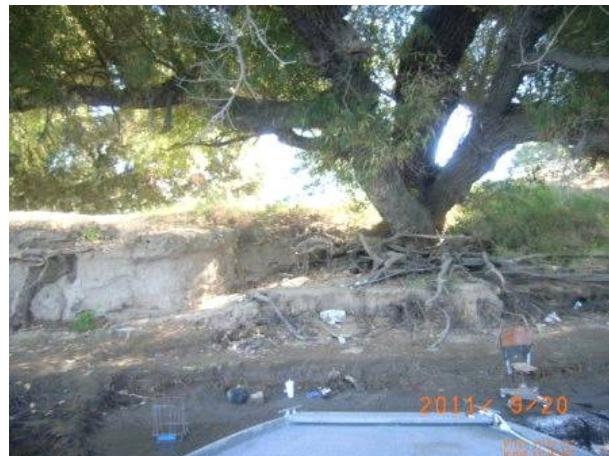
Levee Mile Report Line	38
Start Levee Mile	1.91
End Levee Mile	1.95
Location	Water Side
Category	Supplemental
Item	USACE Erosion Survey
USACE 2011 Photo #2	
<a href="#">USACE2011_SAC_53-8_L_2.jpg</a>

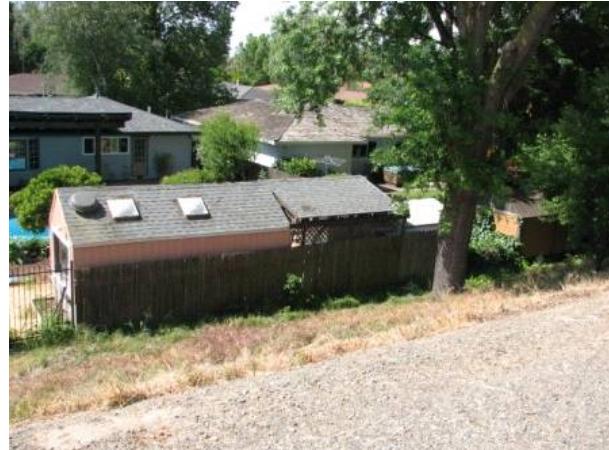
The wooden fence and building are along the toe of the levee.

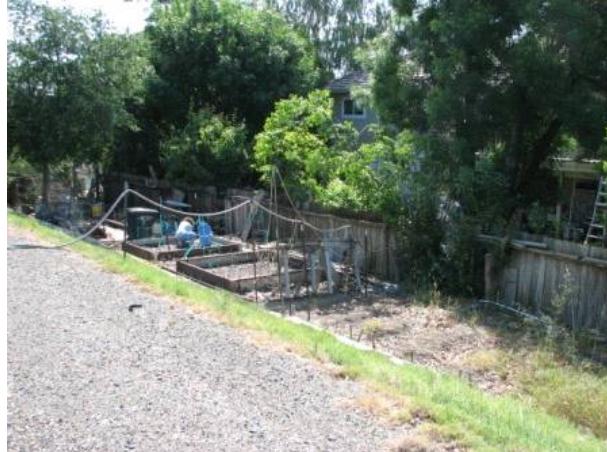
Levee Mile Report Line	42
Start Levee Mile	2.85
End Levee Mile	2.86
Location	Land Side
Category	Earthen Levee
Item	Encroachments
The garden area is at the toe of the levee.	
<i>johngw_f_20111007_884.jpg</i>

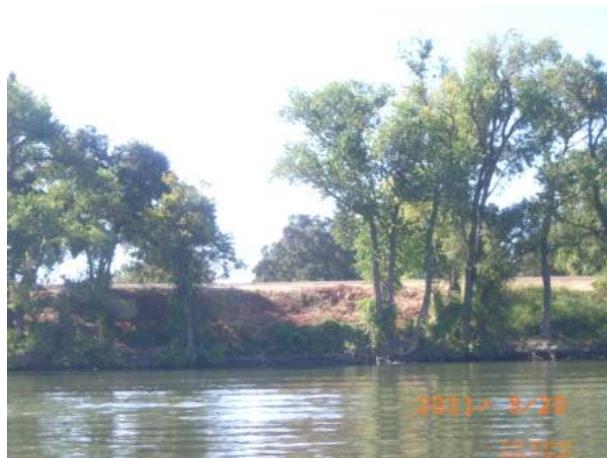
Levee Mile Report Line	51
Start Levee Mile	3.04
End Levee Mile	3.10
Location	Water Side
Category	Supplemental
Item	USACE Erosion Survey
USACE 2011 Photo #1	
<i>USACE2011_SAC_52-7_L_1.jpg</i>

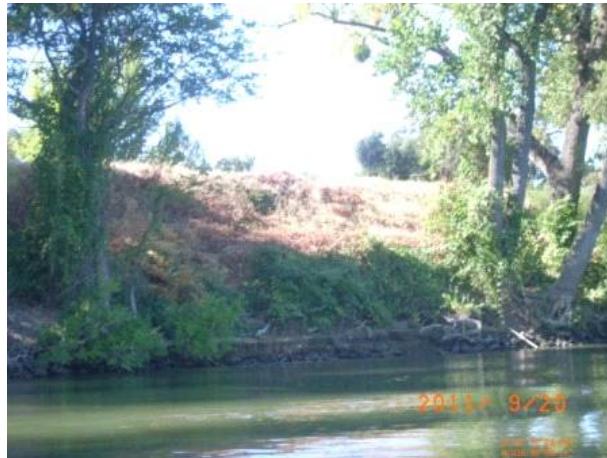
Levee Mile Report Line	51
Start Levee Mile	3.04
End Levee Mile	3.10
Location	Water Side
Category	Supplemental
Item	USACE Erosion Survey
USACE 2011 Photo #2	
<i>USACE2011_SAC_52-7_L_2.jpg</i>

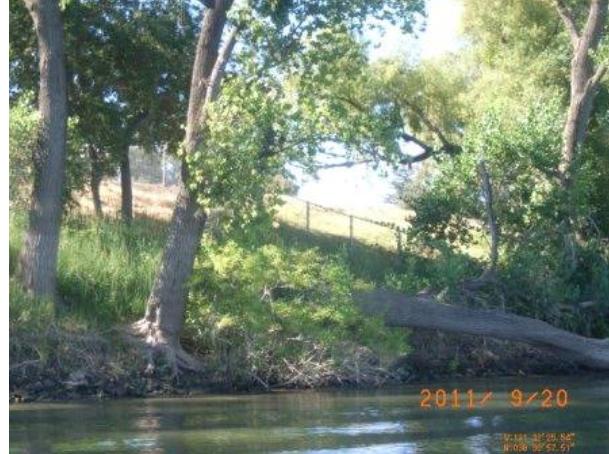
Levee Mile Report Line	51
Start Levee Mile	3.04
End Levee Mile	3.10
Location	Water Side
Category	Supplemental
Item	USACE Erosion Survey
USACE 2011 Photo #3	
USACE2011_SAC_52-7_L_3.jpg

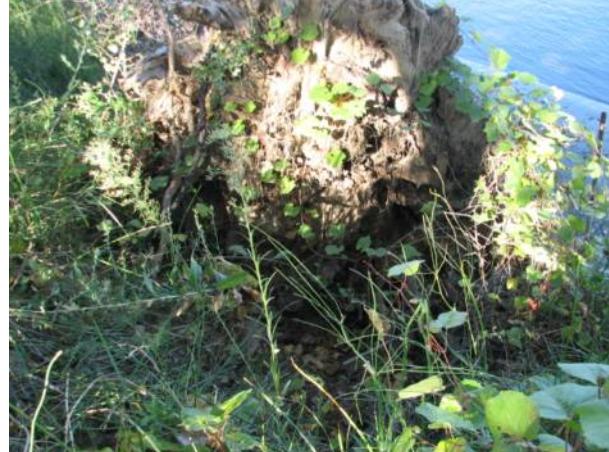
Levee Mile Report Line	55
Start Levee Mile	3.16
End Levee Mile	3.16
Location	Water Side
Category	Earthen Levee
Item	Encroachments
The rootball has left a small hole behind it. Fall 2011	
<a href="#">johngw_f_20111107_513.jpg</a>

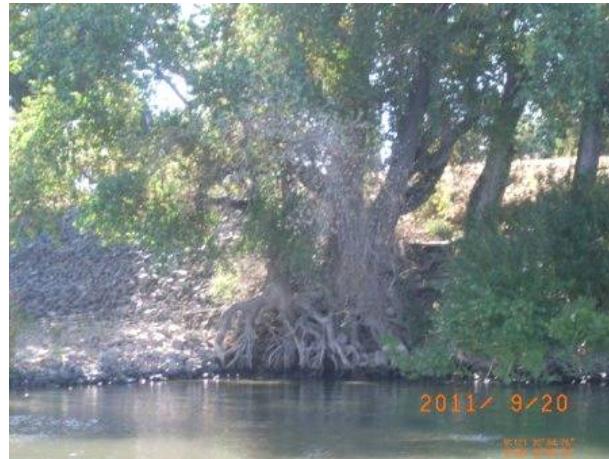
Levee Mile Report Line	65
Start Levee Mile	3.27
End Levee Mile	3.29
Location	Water Side
Category	Supplemental
Item	USACE Erosion Survey
USACE 2011 Photo #1	
<a href="#">USACE2011_SAC_52-4_L_1.jpg</a>

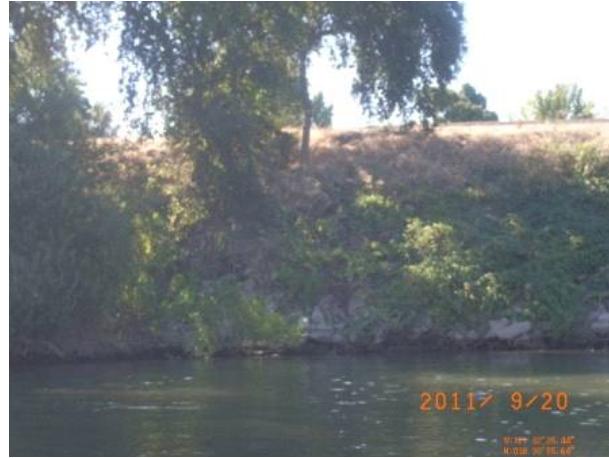
Levee Mile Report Line	65
Start Levee Mile	3.27
End Levee Mile	3.29
Location	Water Side
Category	Supplemental
Item	USACE Erosion Survey
USACE 2011 Photo #2	
<a href="#">USACE2011_SAC_52-4_L_2.jpg</a>

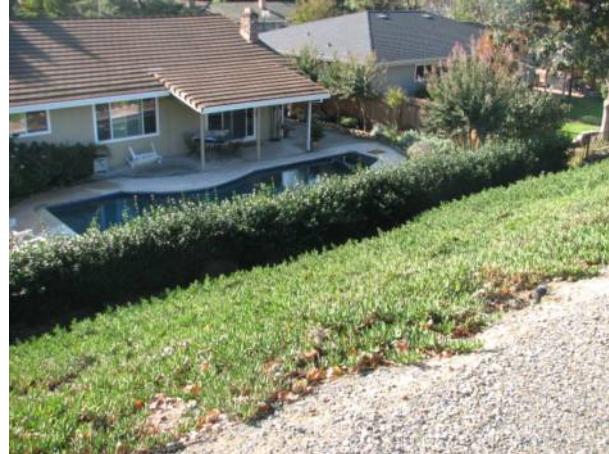
Levee Mile Report Line	66
Start Levee Mile	3.28
End Levee Mile	3.30
Location	Land Side
Category	Earthen Levee
Item	Encroachments
A fence and retaining wall with star jasmine growing on it blocks view of the toe. Fall 2011	
<a href="#">johngw_f_20111107_514.jpg</a>

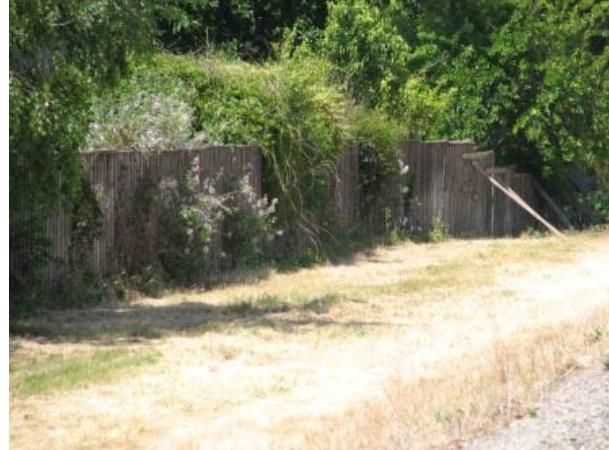
Levee Mile Report Line	73
Start Levee Mile	3.65
End Levee Mile	3.69
Location	Land Side
Category	Earthen Levee
Item	Encroachments
The fence is of solid construction and blocks visibility.	
<i>johngw_f_20111007_890.jpg</i>

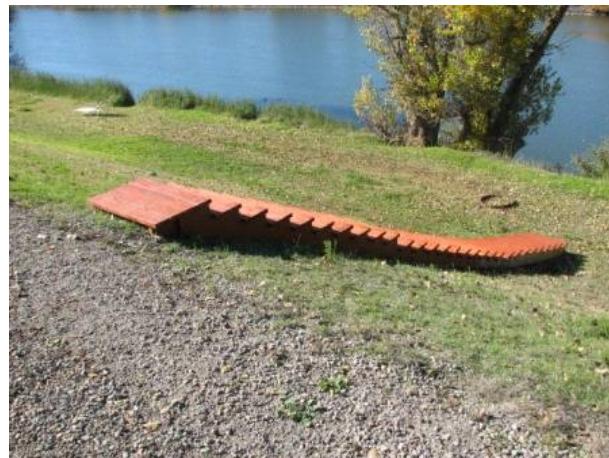
Levee Mile Report Line	92
Start Levee Mile	3.96
End Levee Mile	3.98
Location	Land Side
Category	Earthen Levee
Item	Encroachments
Wooden stairs are on the waterside levee slope.	
<i>johngw_f_20111007_891.jpg</i>

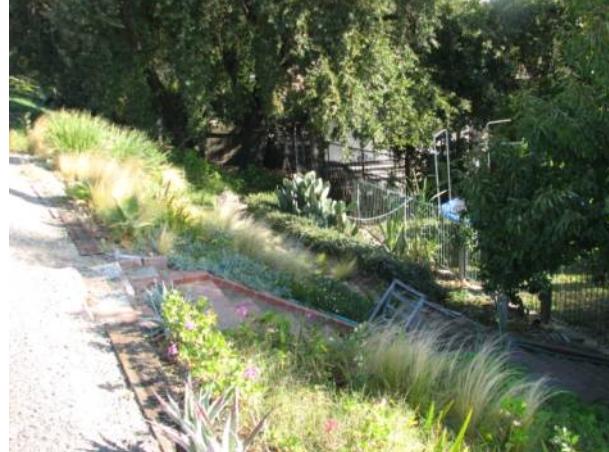
Levee Mile Report Line	97
Start Levee Mile	4.05
End Levee Mile	4.07
Location	Land Side
Category	Earthen Levee
Item	Encroachments
The homeowner has planted cactus and other shrubs landscaped with steps. Fall 2011	
<a href="#">johngw_f_20111107_515.jpg</a>

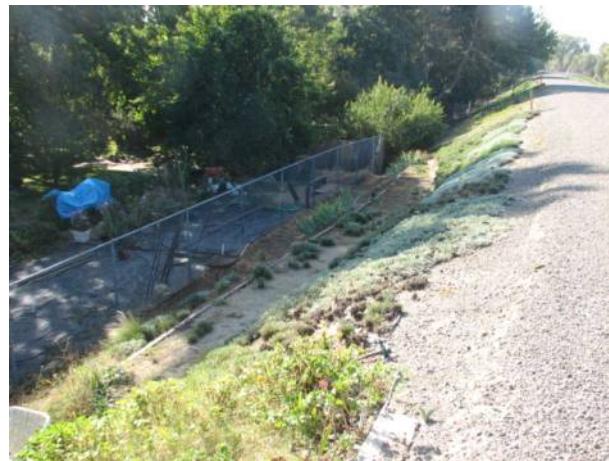
Levee Mile Report Line	98
Start Levee Mile	4.07
End Levee Mile	4.08
Location	Land Side
Category	Earthen Levee
Item	Encroachments
The homeowner has planted groundcover and installed retaining walls. Fall 2011	
<a href="#">johngw_f_20111107_516.jpg</a>

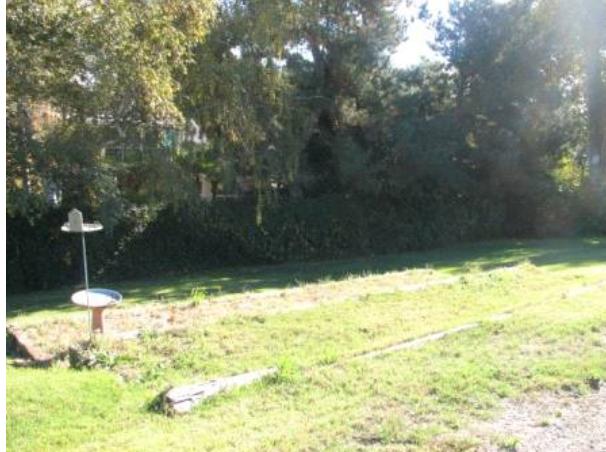
Levee Mile Report Line	104
Start Levee Mile	4.23
End Levee Mile	4.25
Location	Land Side
Category	Earthen Levee
Item	Encroachments
Landscaping and a fence on levee slope.	
<i>johngw_f_20111007_895.jpg</i>

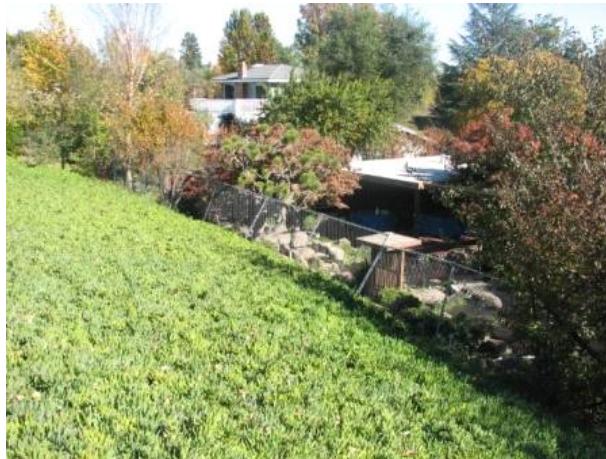
Levee Mile Report Line	107
Start Levee Mile	4.30
End Levee Mile	4.32
Location	Land Side
Category	Earthen Levee
Item	Encroachments
Chain link fence leaning towards the backyard with ice plant on the slope.	
<i>johngw_f_20111007_896.jpg</i>

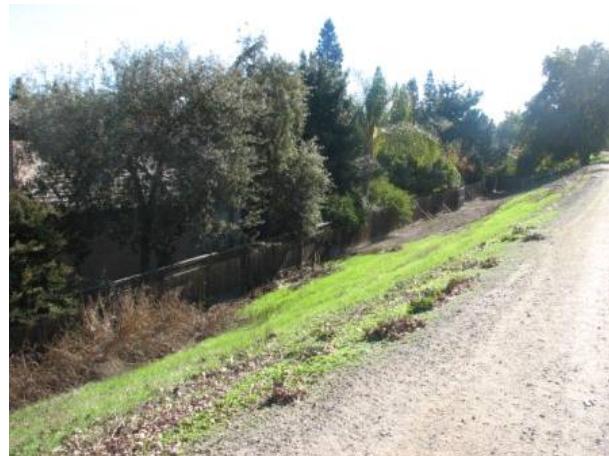
Levee Mile Report Line	124
Start Levee Mile	4.69
End Levee Mile	4.75
Location	Land Side
Category	Earthen Levee
Item	Encroachments
Wooden fence along the levee toe makes visibility difficult.	johngw_f_20111007_897.jpg

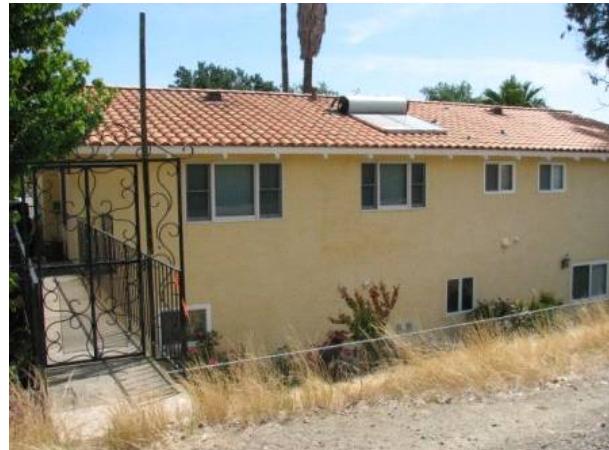
Levee Mile Report Line	130
Start Levee Mile	5.02
End Levee Mile	5.02
Location	Land Side
Category	Earthen Levee
Item	Encroachments
The two storey house was built at the toe of the levee.	johngw_f_20111007_898.jpg

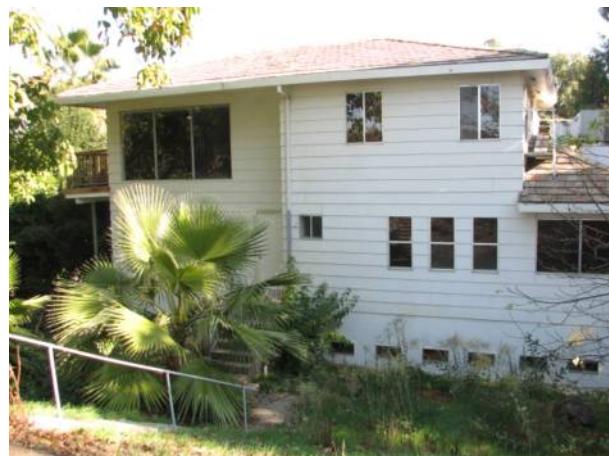
Levee Mile Report Line	132
Start Levee Mile	5.04
End Levee Mile	5.04
Location	Land Side
Category	Earthen Levee
Item	Encroachments
The house is within the easement of the levee. Fall 2011	johngw_f_20111107_518.jpg

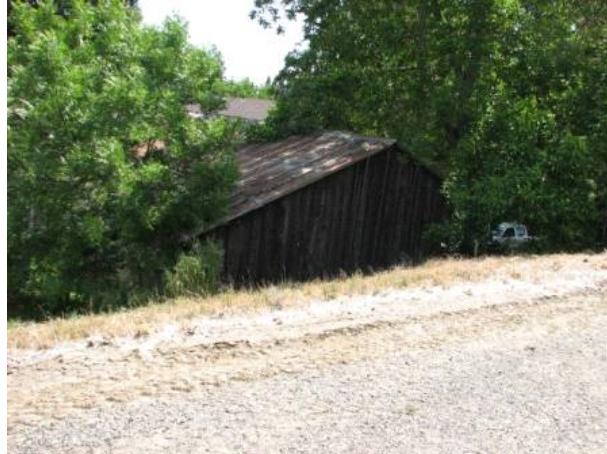
Levee Mile Report Line	133
Start Levee Mile	5.05
End Levee Mile	5.05
Location	Land Side
Category	Earthen Levee
Item	Encroachments
The side of the barn is into levee toe.	
<i>johngw_f_20111007_900.jpg</i>

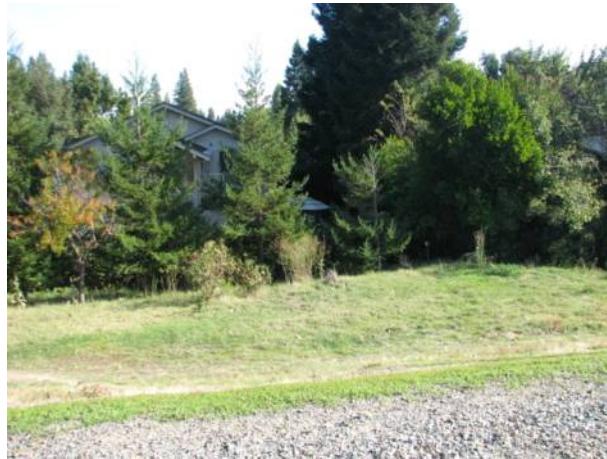
Levee Mile Report Line	135
Start Levee Mile	5.23
End Levee Mile	5.29
Location	Land Side
Category	Earthen Levee
Item	Encroachments
A fence and shrubs are on the levee slope. Fall 2011	
<i>johngw_f_20111107_519.jpg</i>

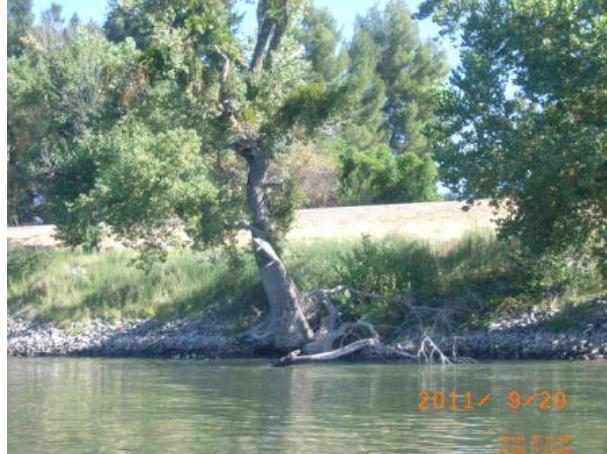
USACE 2011 Photo #1

Levee Mile Report Line	139
Start Levee Mile	5.35
End Levee Mile	5.35
Location	Water Side
Category	Supplemental
Item	USACE Erosion Survey

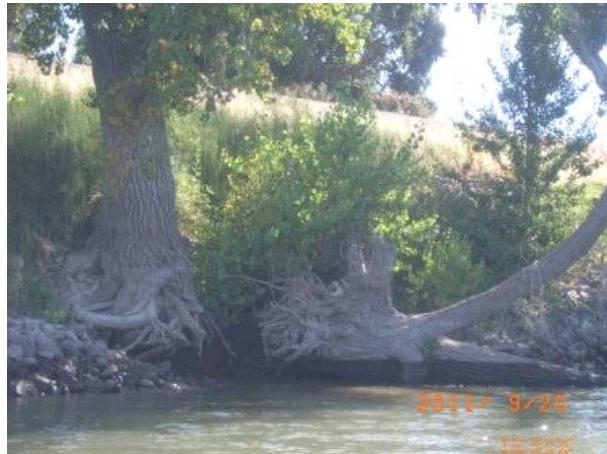
USACE 2011 Photo #2

Levee Mile Report Line	139
Start Levee Mile	5.35
End Levee Mile	5.35
Location	Water Side
Category	Supplemental
Item	USACE Erosion Survey

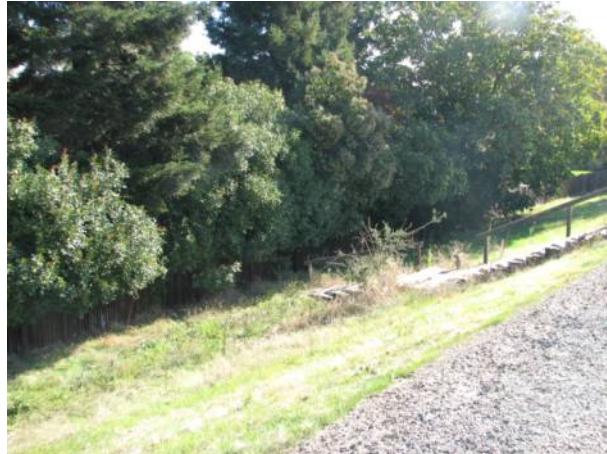
johngw\_f\_20111107\_520.jpg

Levee Mile Report Line	144
Start Levee Mile	5.55
End Levee Mile	5.58
Location	Land Side
Category	Earthen Levee
Item	Encroachments

The landscape and fence blocks the view of the toe . Fall 2011

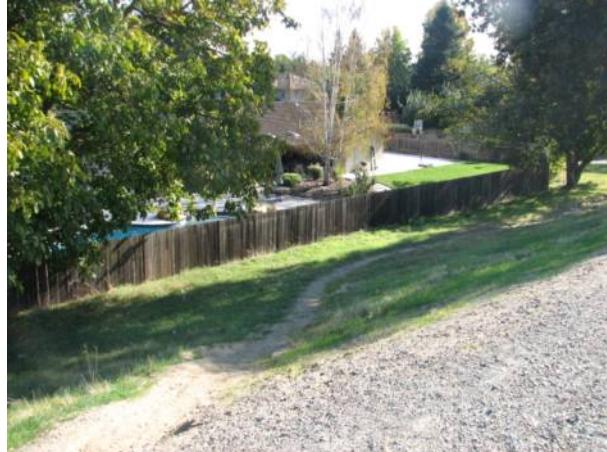
Levee Mile Report Line	145
Start Levee Mile	5.58
End Levee Mile	5.60
Location	Land Side
Category	Earthen Levee
Item	Encroachments
A solid fence was built at the toe of the levee. Fall 2011	
<i>johngw_f_20111107_521.jpg</i>

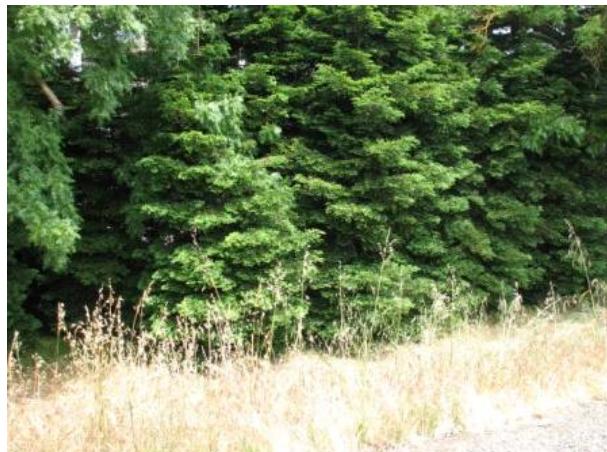
Levee Mile Report Line	148
Start Levee Mile	6.90
End Levee Mile	6.90
Location	Land Side
Category	Earthen Levee
Item	Encroachments
The Redwood trees are blocking the view.	
<i>johngw_f_20111107_903.jpg</i>

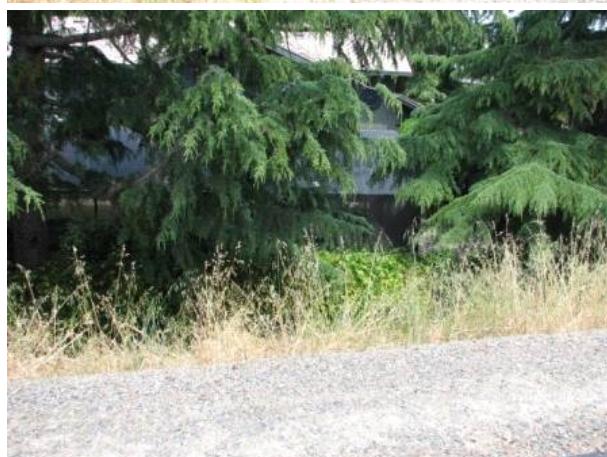
Levee Mile Report Line	151
Start Levee Mile	7.38
End Levee Mile	7.39
Location	Land Side
Category	Earthen Levee
Item	Encroachments
A solid fence and landscape need to be trimmed.	
<i>johngw_f_20111107_904.jpg</i>

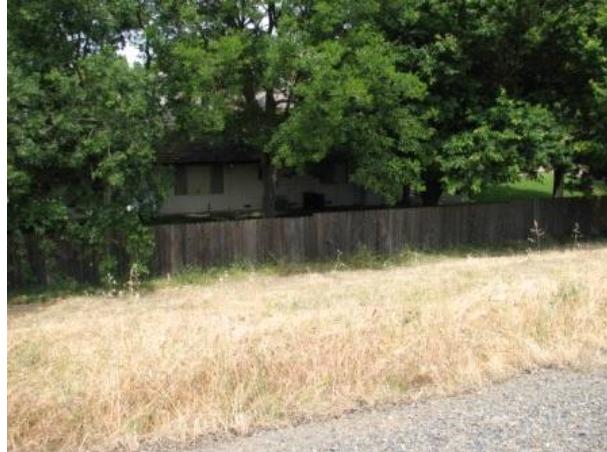
Levee Mile Report Line	152
Start Levee Mile	7.52
End Levee Mile	7.55
Location	Land Side
Category	Earthen Levee
Item	Encroachments
Another solid fence along the slope.	
<i>johngw_f_20111007_905.jpg</i>

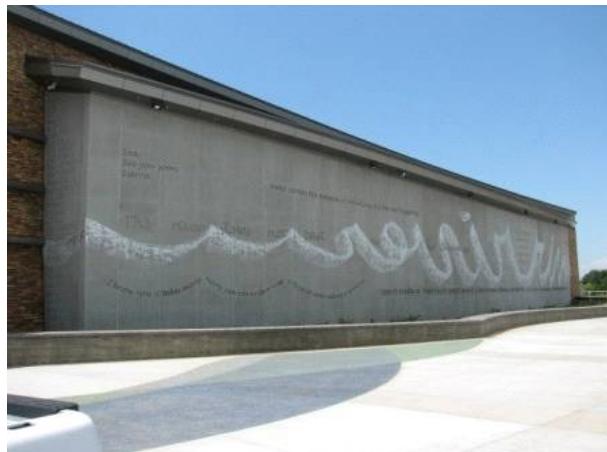
Levee Mile Report Line	155
Start Levee Mile	8.60
End Levee Mile	8.60
Location	Crown
Category	Earthen Levee
Item	Encroachments
This is the new East Bay MUD pumping plant.	
<i>johngw_f_20111007_863.jpg</i>

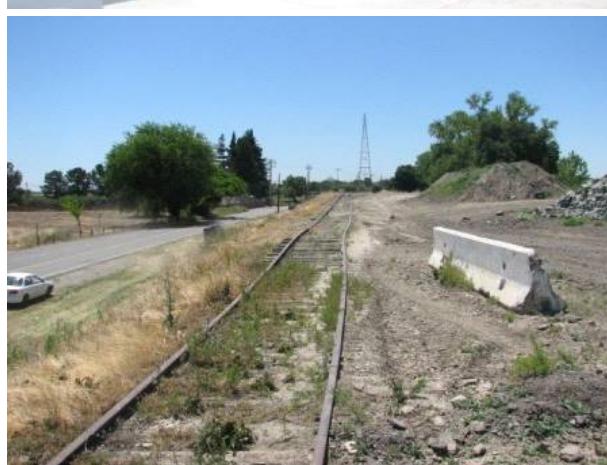
Levee Mile Report Line	156
Start Levee Mile	8.85
End Levee Mile	10.63
Location	Crown
Category	Earthen Levee
Item	Encroachments
The railroad tracks are on the crown of the levee from here to Cliffs marina.	
<i>johngw_f_20111007_906.jpg</i>

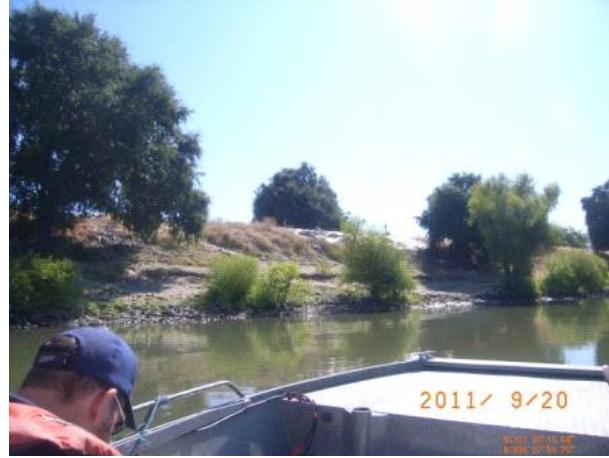
USACE 2011 Photo #1

Levee Mile Report Line	158
Start Levee Mile	9.07
End Levee Mile	9.22
Location	Water Side
Category	Supplemental
Item	USACE Erosion Survey

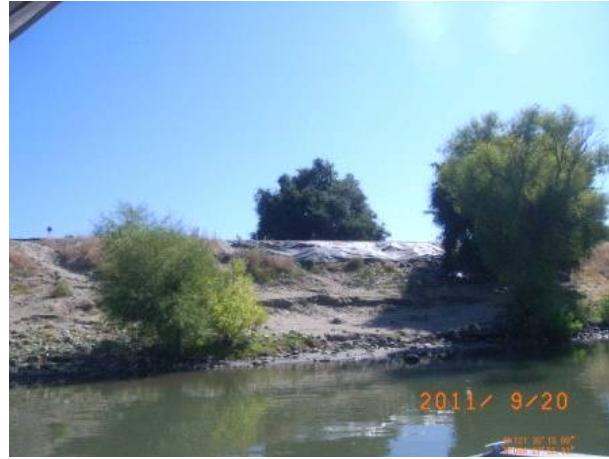
USACE 2011 Photo #2

Levee Mile Report Line	158
Start Levee Mile	9.07
End Levee Mile	9.22
Location	Water Side
Category	Supplemental
Item	USACE Erosion Survey

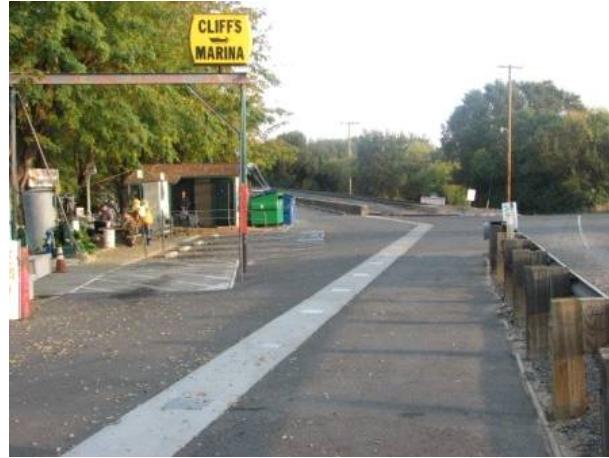
johngw\_f\_20111007\_907.jpg

Levee Mile Report Line	180
Start Levee Mile	10.64
End Levee Mile	10.64
Location	Water Side
Category	Earthen Levee
Item	Encroachments

This is a photo of the flood wall that was installed earlier.

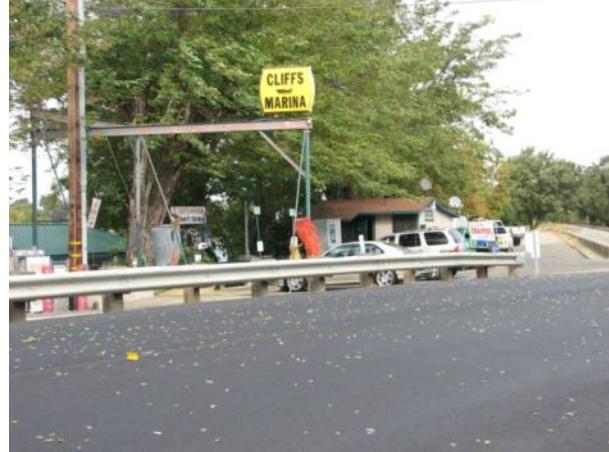
Levee Mile Report Line	180
Start Levee Mile	10.64
End Levee Mile	10.64
Location	Water Side
Category	Earthen Levee
Item	Encroachments
Cliffs marina is on the waterside of the levee crown. The levee crown is HWY 160 and at this point the HWY drops off the crown. Fall 2011	
<a href="#">johngw_f_20111107_478.jpg</a>

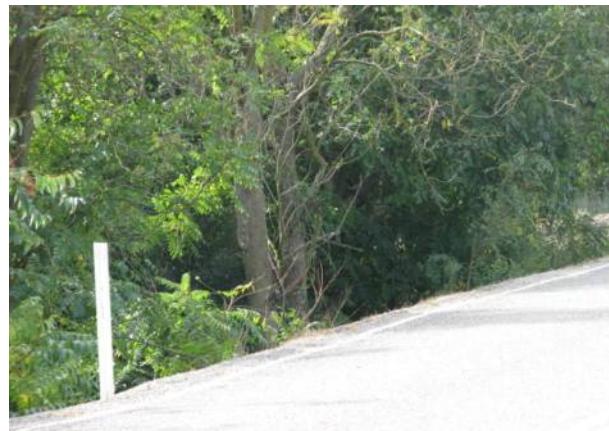
Levee Mile Report Line	185
Start Levee Mile	11.14
End Levee Mile	11.14
Location	Land Side
Category	Earthen Levee
Item	Encroachments
The landscape shrubs and trees are on the levee slope and block visibility. Fall 2011	
<a href="#">johngw_f_20111107_479.jpg</a>

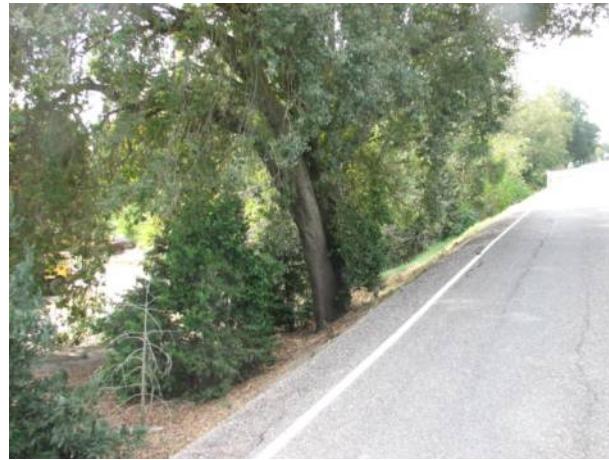
Levee Mile Report Line	186
Start Levee Mile	11.18
End Levee Mile	11.18
Location	Land Side
Category	Earthen Levee
Item	Encroachments
There is landscaping planted on the levee slope. Fall 2011	
<a href="#">johngw_f_20111107_480.jpg</a>

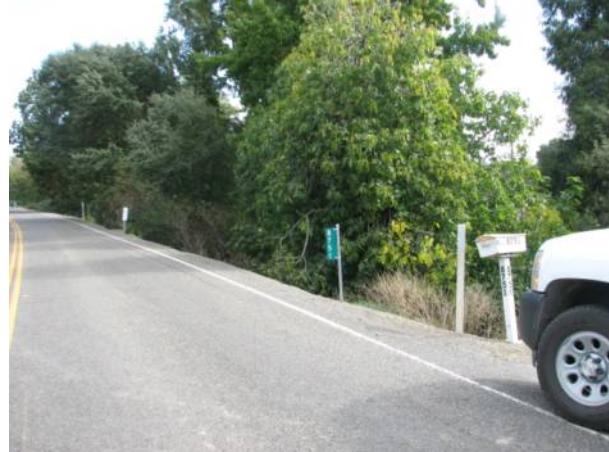
Levee Mile Report Line	187
Start Levee Mile	11.21
End Levee Mile	11.21
Location	Land Side
Category	Earthen Levee
Item	Encroachments
Landscape trees are blocking visibility. Fall 2011	johngw_f_20111107_481.jpg

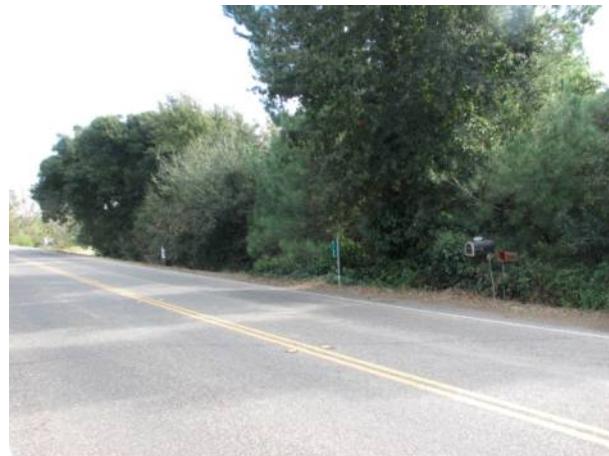
Levee Mile Report Line	189
Start Levee Mile	11.46
End Levee Mile	11.46
Location	Land Side
Category	Earthen Levee
Item	Encroachments
The landscaping is planted on the levee slope and shoulder. Fall 2011	johngw_f_20111107_482.jpg

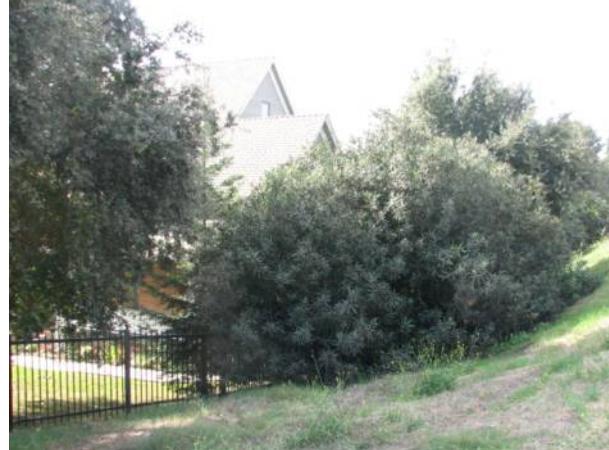
Levee Mile Report Line	191
Start Levee Mile	11.67
End Levee Mile	11.67
Location	Land Side
Category	Earthen Levee
Item	Encroachments
The building and landscape shrubs are at the toe of the levee. Fall 2011	
<i>johngw_f_20111107_484.jpg</i>

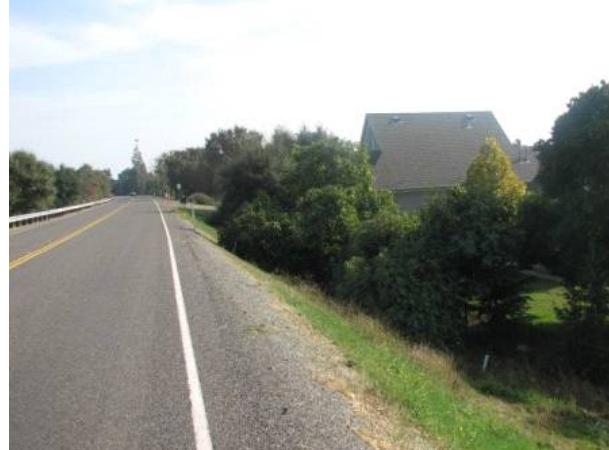
Levee Mile Report Line	192
Start Levee Mile	11.68
End Levee Mile	11.68
Location	Land Side
Category	Earthen Levee
Item	Encroachments
Fence and shrubs are along the toe of the levee.	
<i>johngw_f_20111107_919.jpg</i>

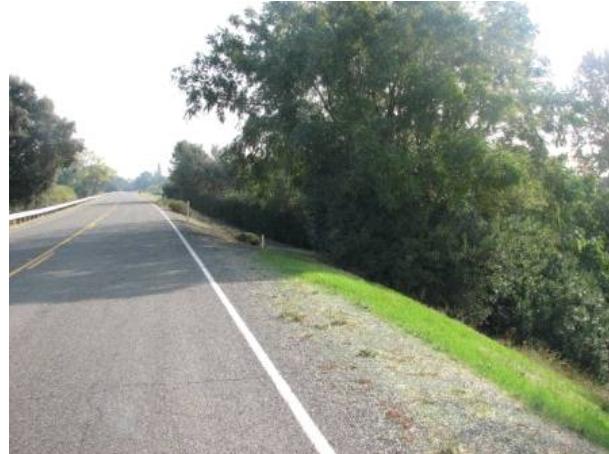
Levee Mile Report Line	194
Start Levee Mile	12.14
End Levee Mile	12.14
Location	Land Side
Category	Earthen Levee
Item	Encroachments
Oleanders are planted on the levee toe and slope to screen the house.	
<i>johngw_f_20111107_918.jpg</i>

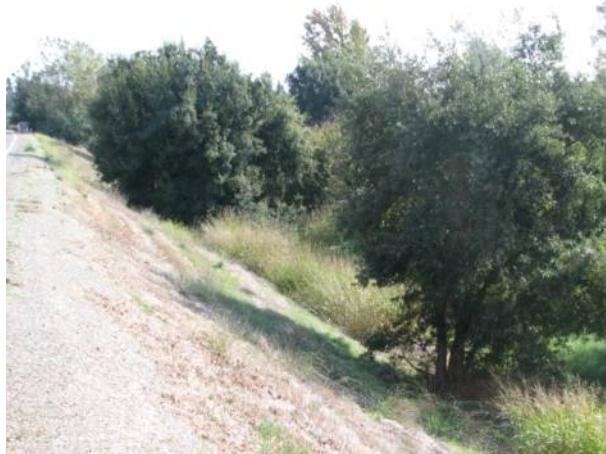
johngw\_f\_20111107\_485.jpg

Levee Mile Report Line	195
Start Levee Mile	12.27
End Levee Mile	12.27
Location	Land Side
Category	Earthen Levee
Item	Vegetation

The Johnson grass blocks the view of the levee toe. Fall 2011

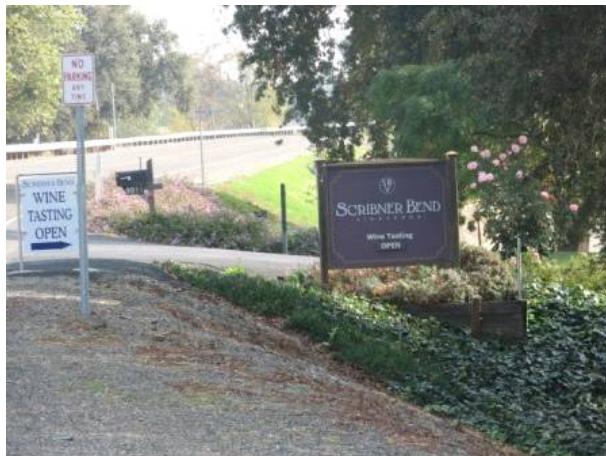
johngw\_f\_20111107\_920.jpg

Levee Mile Report Line	196
Start Levee Mile	12.54
End Levee Mile	12.54
Location	Land Side
Category	Earthen Levee
Item	Encroachments

Groundcover has been planted on the levee slope.

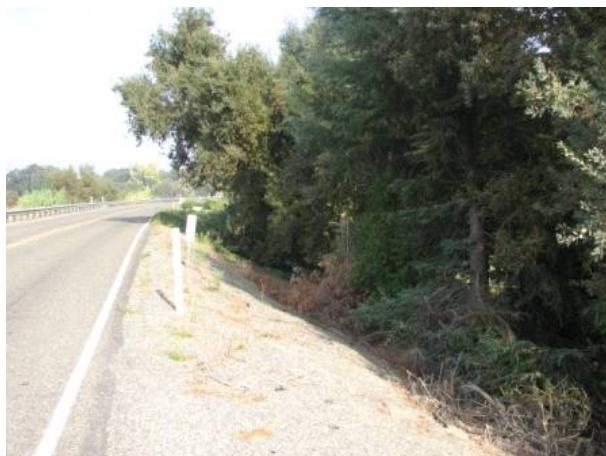
johngw\_f\_20111107\_917.jpg

Levee Mile Report Line	199
Start Levee Mile	12.90
End Levee Mile	12.90
Location	Land Side
Category	Earthen Levee
Item	Encroachments

Trees, shrubs, groundcover, and lawn are planted on the levee.

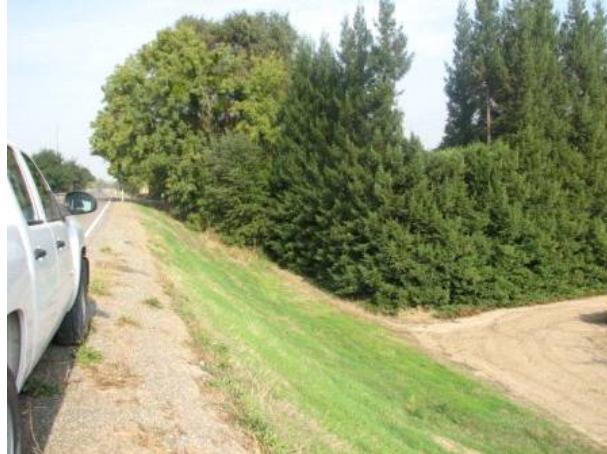
Levee Mile Report Line	200
Start Levee Mile	13.60
End Levee Mile	13.60
Location	Land Side
Category	Earthen Levee
Item	Encroachments
Redwood trees screen a lawn area. The trees are at the toe .	johngw_f_20111007_915.jpg

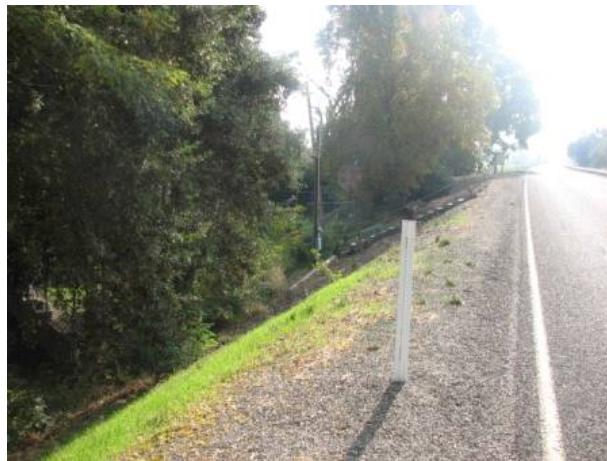
Levee Mile Report Line	200
Start Levee Mile	13.60
End Levee Mile	13.60
Location	Land Side
Category	Earthen Levee
Item	Encroachments
Steps and landscaping on slope in front of the house.	johngw_f_20111007_916.jpg

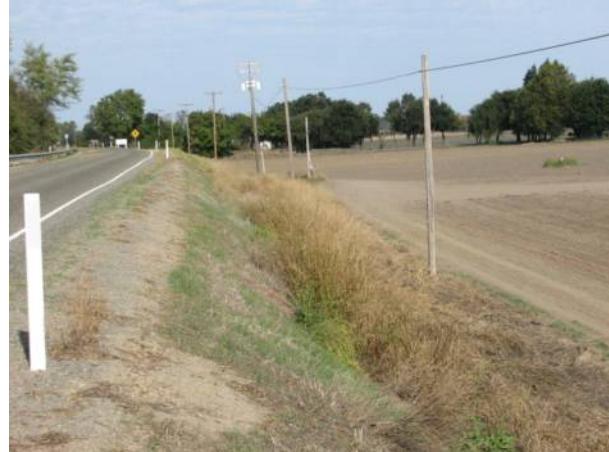
Levee Mile Report Line	202
Start Levee Mile	14.57
End Levee Mile	14.77
Location	Land Side
Category	Earthen Levee
Item	Vegetation
The Johnson grass has been sprayed but blocks the view of the toe of the levee. Fall 2011	
johngw_f_20111107_486.jpg

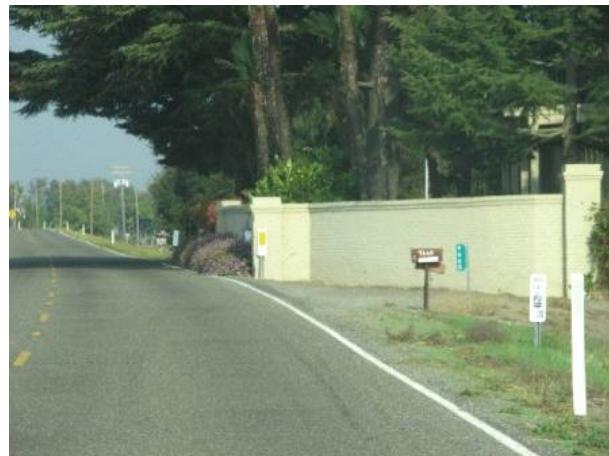
Levee Mile Report Line	203
Start Levee Mile	14.93
End Levee Mile	14.93
Location	Land Side
Category	Earthen Levee
Item	Encroachments
Painted brick wall acts as a sound barrier for the house on the levee.	
johngw_f_20111107_922.jpg

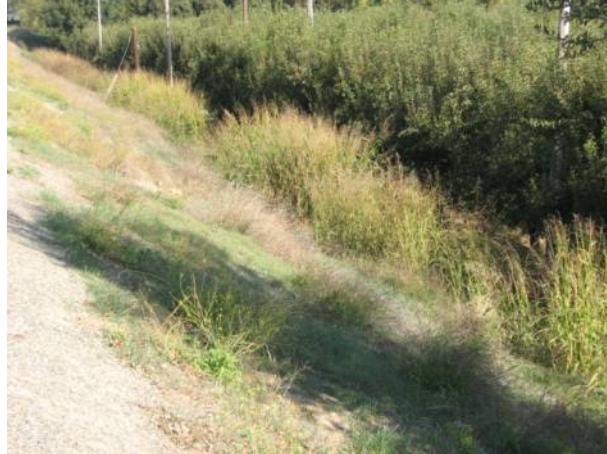
Levee Mile Report Line	205
Start Levee Mile	15.32
End Levee Mile	15.46
Location	Land Side
Category	Earthen Levee
Item	Vegetation
The Johnson grass blocks the view of the toe of the levee. Fall 2011	
<i>johngw_f_20111107_487.jpg</i>

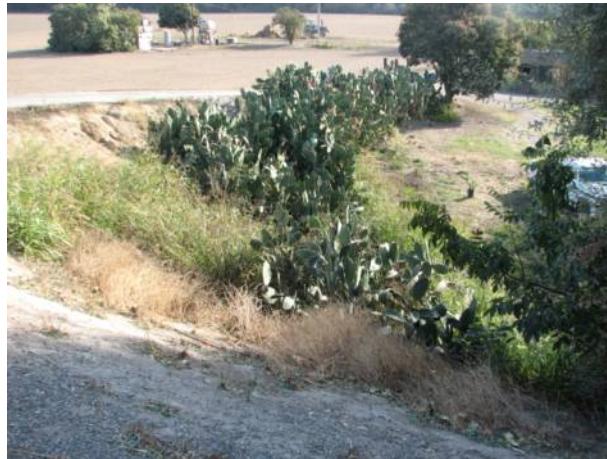
Levee Mile Report Line	207
Start Levee Mile	15.94
End Levee Mile	15.94
Location	Land Side
Category	Earthen Levee
Item	Vegetation
Some cactus is planted at the toe of the levee. Fall 2011	
<i>johngw_f_20111107_488.jpg</i>

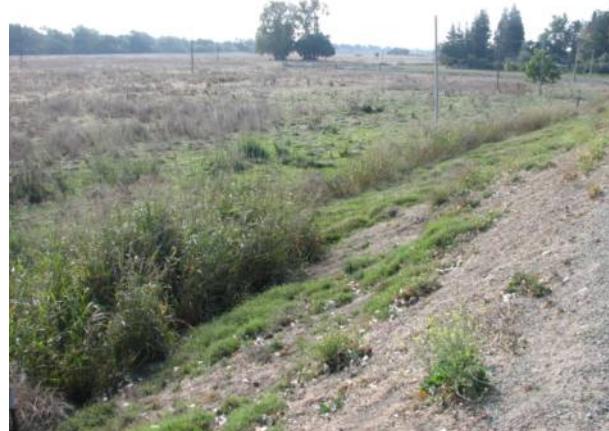
Levee Mile Report Line	209
Start Levee Mile	16.01
End Levee Mile	16.10
Location	Land Side
Category	Earthen Levee
Item	Vegetation
Tall Johnson grass blocks the view of the toe. Fall 2011	
johngw_f_20111107_489.jpg

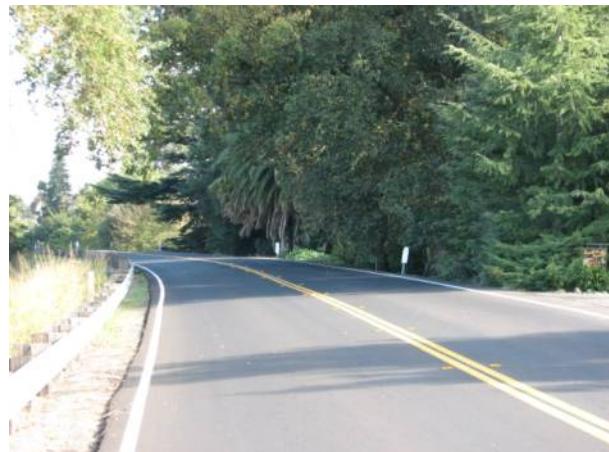
Levee Mile Report Line	210
Start Levee Mile	16.15
End Levee Mile	16.32
Location	Land Side
Category	Earthen Levee
Item	Encroachments
The landscape vegetation is planted on the levee slope and shoulder. Fall 2011	
johngw_f_20111107_490.jpg

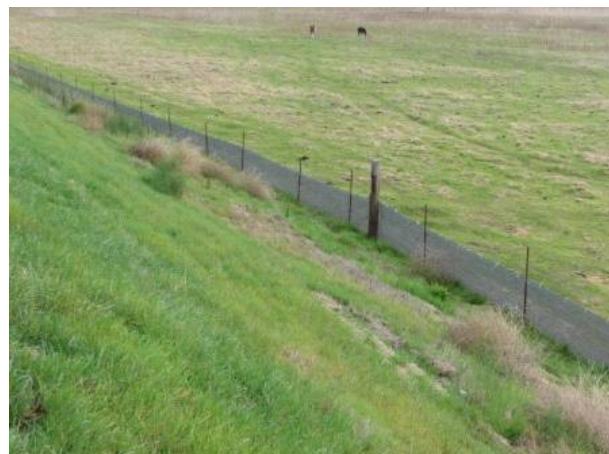
Levee Mile Report Line	212
Start Levee Mile	16.34
End Levee Mile	16.66
Location	Land Side
Category	Earthen Levee
Item	Encroachments
No permit for fence at toe.	
johngw_f_20111107_924.jpg

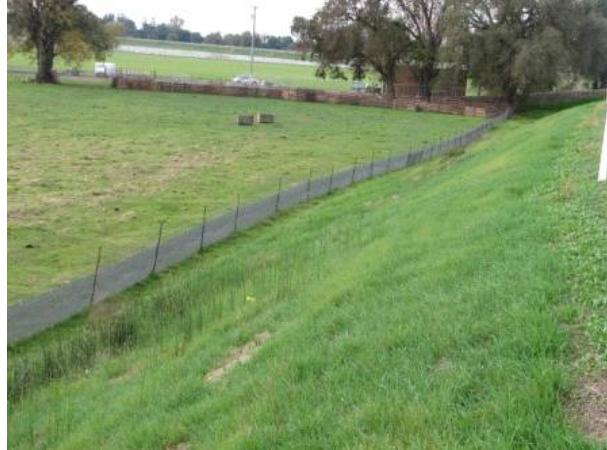
Levee Mile Report Line	212
Start Levee Mile	16.34
End Levee Mile	16.66
Location	Land Side
Category	Earthen Levee
Item	Encroachments
No permit for fence at toe.	
<i>johngw_f_20111007_925.jpg</i>

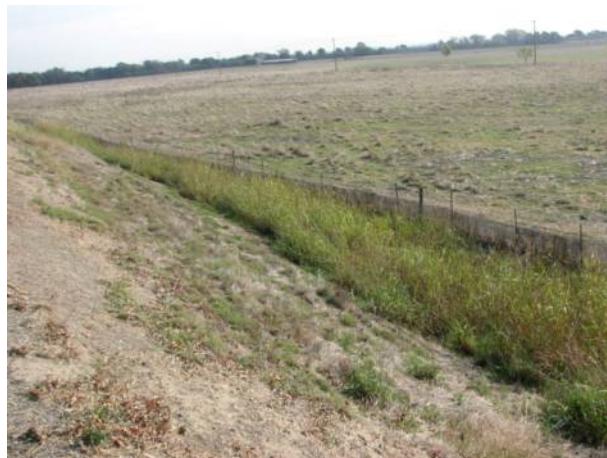
Levee Mile Report Line	214
Start Levee Mile	16.57
End Levee Mile	16.64
Location	Land Side
Category	Earthen Levee
Item	Vegetation
Johnson grass is growing at the toe next to the fence. Fall 2011	
<i>johngw_f_20111107_491.jpg</i>
